Thermal Patterns in the Snow: Icicles as Indicators of Heat Loss

Albert A. Bartlett
University of Colorado at Boulder, CO
The Physics Teacher, Vol. 46, March 2008

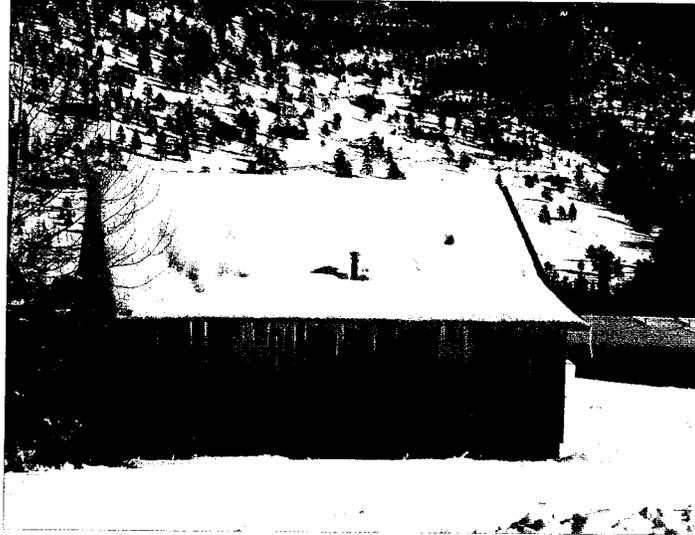
Fig. 2. West face of a cabin (12/31/06). The South Eave Effect is seen clearly on the south edge of the roof at the right.

The snow on the roof of the cabin in Fig. 2 appears to be reasonably uniform in thickness, which suggests insulation in the form of batts of insulation such as fiberglass on the underside of the roof. There are a few scattered dimples in the snow, which suggest a random pattern of faults in the placement of this insulation. Understandably, the snow is melted around the sheet metal stovepipe. We can see the South Eave Effect developing on the right side of the roof. The few icicles suggest that there has been some melting of the snow from a combination of heat flow from the interior plus solar energy input on the roof.

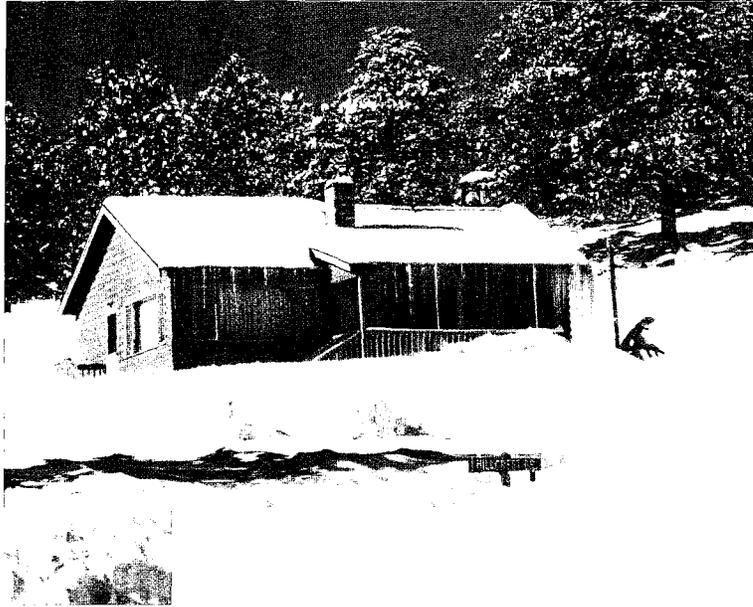
Fig. 3. East face of a cabin (12/30/06). The South Eave Effect is starting to develop on the left of the roof, and the piled up snow on the overhanging north eave at the right is a demonstration of the North Eave Effect.

In Fig. 3 we are looking at a heated cabin that faces approximately east. At the left edge, a narrow strip of bare roof is the result of the South Eave Effect. The snow appears to be of full thickness on the left half of the roof and on the roof of the porch. The snow appears to be at full thickness on the right (north) cove. This is a dramatic example of the North Eave Effect. Why is the snow almost all melted away on the right half of the roof? When you enter the typical cabin such as this from the porch, you enter the living/diningroom, which is the right part of the building in the photo. The bedrooms are in the left part of the building. The living room has an open cathedral-style ceiling, which allows the warm air in the living room to convert upward and heat the underside of the roof boards, melting snow on the roof. The warm interior air tends to collect at the peak of the interior space.

so that there is a thermal gradient of increasing inside air temperatures as you go up to the peak of the roof. As a result, one would expect the outside snow to be thinnest at the peak of the roof, indicating the gradient of the inside air temperatures. Indeed, the snow appears to be completely melted on a very narrow strip at the highest part of the roof. The bedroom space has a horizontal flat drywall ceiling, which isolates the warm air in the bedrooms from the air in the triangular space above the ceiling and under the roof. There may be thermal insulation over the drywall. The combination of isolation and insulation reduces the heat flow from the bedroom

ceiling into the cooler space above the ceiling and under the roof, so relatively little snow has been melted from the roof over the bedrooms. The temperature of the underside of the porch roof is probably the temperature of the outside ambient air, so there is little melting of the snow on the porch roof. Notice that there are icicles along the edge of the porch. Most of their water probably came from thermal conduction through the roof over the living room. The icicles on the left edge of the roof arise probably from a combination of heat loss through the roof over the bedrooms and solar input from the afternoon Sun.

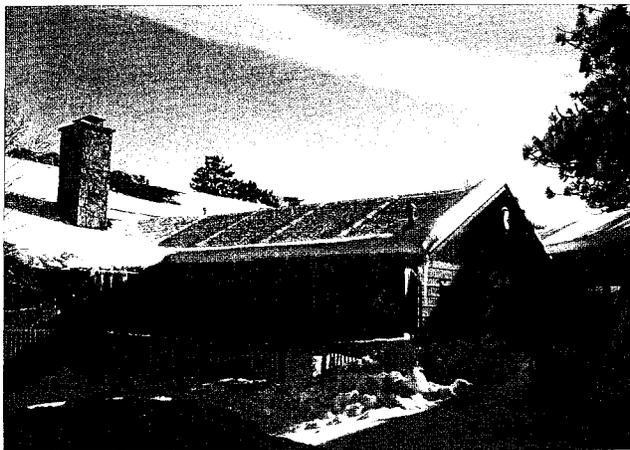
Fig. 5. Looking southeast at the north roof of a lodge building. This roof appears to be a superhighway for the escape of heat from the interior of the building. The large thickness of snow on the lower edge of the roof and on the right (west) edge are examples of the North Eave Effect (12/31/06).

The building in Fig. 5 is one of the lodge buildings whose roof has an exquisite snow pattern. We are looking at the north side of the building, so we see the North Eave Effect of thick snow along the north (lower) edge of the roof. We see the same effect on the cove to the right, probably because trees or other buildings are keeping the afternoon Sun from striking much of this west wall. There seems to be little or no insulation in the roof as is indicated by the four large rectangular sections of the roof where the snow is almost completely melted. This melting has given rise to the dense curtain of icicles on the near edge of the roof. The roof sections are identified by four lines of snow running up the roof. These lines of snow most certainly identify the position of four major structural roof beams, which, because of their mass and thickness, provide some insulation to reduce locally the outward heat flow. This pattern is almost like an x-ray of the roof structure. The fifth section to the left of the left beam seems to have more snow than the sections to the right, suggesting the possibility of some insulation under that section of the roof.

The roof of the main part of the building to the left seems to have more snow on the lower part of the roof, indicating that it is probably insulated. It is not clear why there is a large irregular area to the right of the Chimney that is free of snow. Wind can sculpt the snow on roofs, so this could be the result of winds. Because of the different patterns on the two parts of the building, one wonders if the right wing, with all the heat loss, was constructed some time after the construction of the main part of the building to the left, with the roof insulation being different in the two constructions.
